# CHARACTERIZATION OF THE MORTARS OF EL CASTILLO DE SAN CRISTÓBAL

JEREMY C. WELLS

**ABSTRACT** — This study characterizes the formulation of mortars used in the construction of Fort San Cristóbal located in the city of Old San Juan, Puerto Rico. Renders, horizontal surface mortars, and bedding mortars representing a period of time from the late 17th to the early 20th century were sampled from a variety of outworks on the site. Results of examination using optical microscopy/polarized light microscopy and x-ray diffraction show that mortar formulations were closely tied to their uses as well as their time periods. Evidence is presented that the Spanish were using hydraulic brick dust mortars during the second phase of construction at the fort in the late 18th century, in reaction to earlier failure of weak clay/lime mortars.

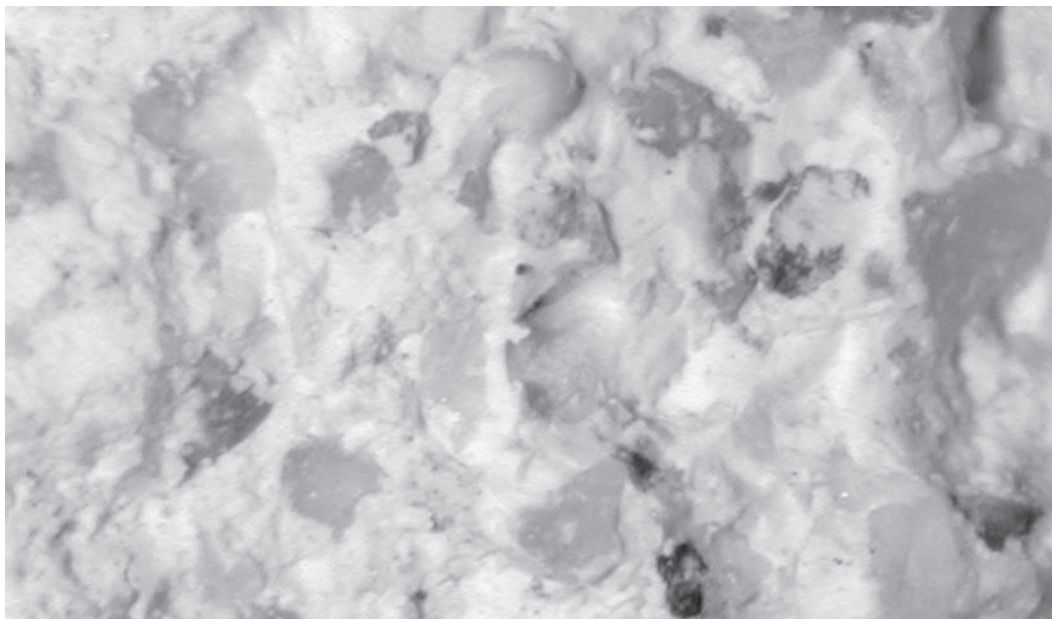
Fig. 11. Interior surface of mortar sample 14M200 under low magnification. The binder is very white, which is aesthetically consistent with a render that is meant to be seen.

All sampled renders have white-colored binders. Of these samples, only 13M200, 14M200, 16M200, and 20M201 have colored surface finishes. This surface finish is quite consistent across samples and manifests itself as a very thin transparent orange layer that does not penetrate very far into the substrate. Samples 13M200, 14M200, and 16M200 have a very smooth polished surface.

The renders were also analyzed via PLM. All of the sands were spherical and rounded. 13M200 and 21M200 had a large amount of bioclasts while 14M200 and 16M200 had a moderate amount. With the exception of 20M201, which was poorly graded, the sands had a medium degree of grading consistent with the use of beach sand for aggregates. Calcite staining and subsequent XRD analysis confirmed that the binder is predominantly calcite.
