# Methods for the Preservation of French Colonial *Poteaux en Terre* (Posts-in-Ground) Houses

JEREMY C. WELLS

**A range of intervention methods are considered for the five known examples of eighteenth- and nineteenth-century posts-in-ground construction that remain in the United States.**

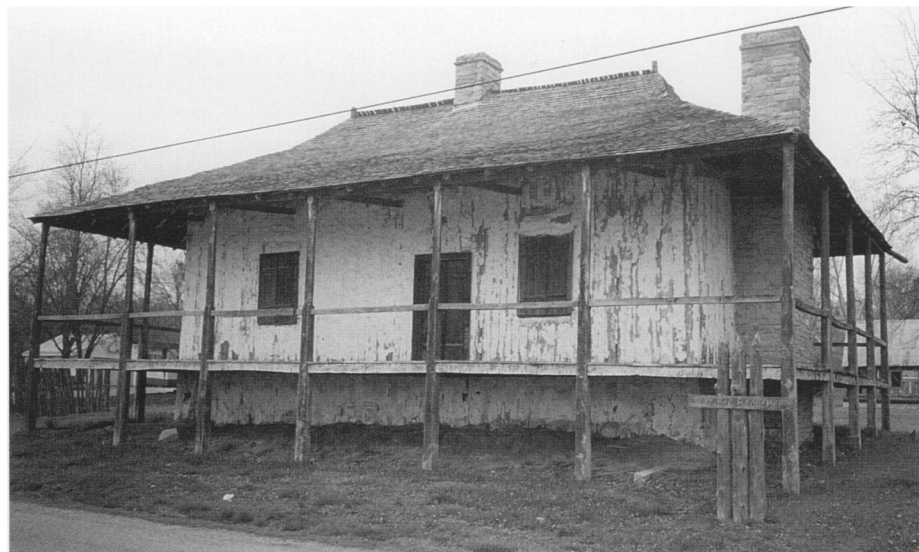
Fig. 1. The Bequette-Ribault house in Ste. Genevieve, Missouri, an example of a posts-in-ground house. All photographs and drawings by the author.

The majority of French Colonial houses incorporated posts-in-ground construction (Figs. 1 and 2). Construction began with digging a trench approximately three feet deep and inserting a row of closely spaced, vertical posts that rose to the full height of the

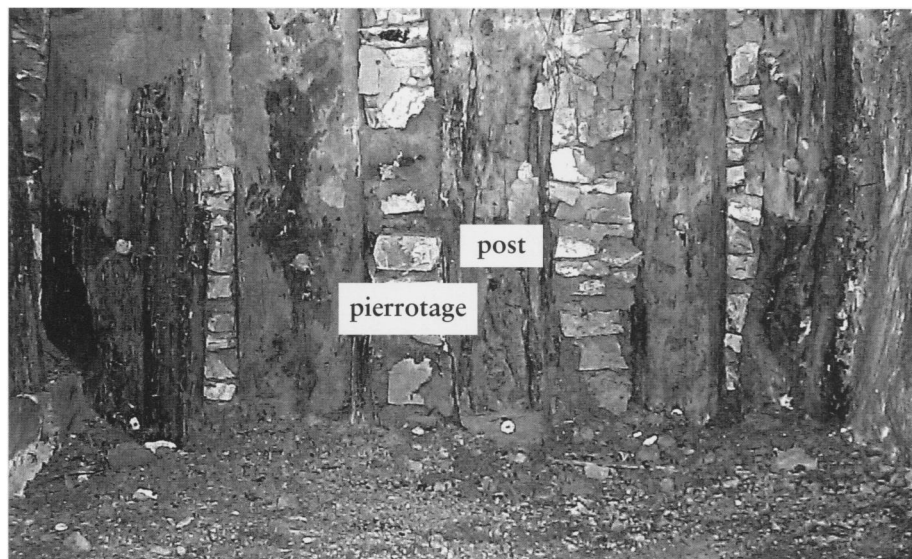
Fig. 2. Posts-in-ground construction viewed from the cellar of the Amoureux house, Ste. Genevieve, Missouri.

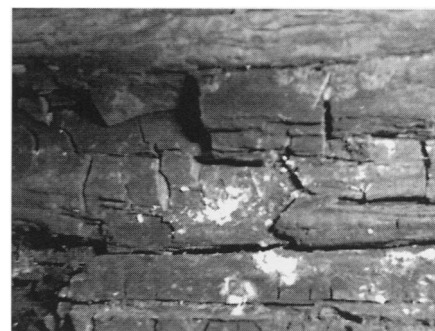
Fig. 3. Detail of fungal decay in an eastern-red-cedar post more than two hundred years old that has been removed from the ground.

the removal of less durable sapwood and the retention of more durable heartwood. The relatively unaltered, round portion of the post would be subject to more decay because it retains a higher percentage of less durable sapwood. In addition, the rounded portion of the post is in direct soil contact, as opposed to the squared-off portion. In the houses studied, the rounded lower portions of the posts exhibit a substantial loss of sapwood through decay (Fig. 3).

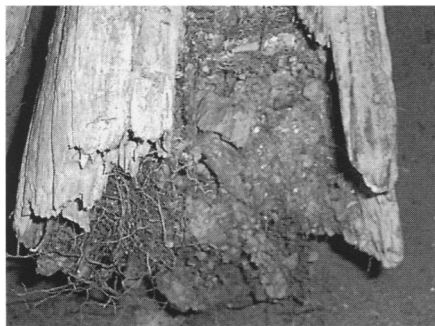
Fig. 4. Decayed, hollowed-out lower portion of a nineteenth-century, eastern-red-cedar post from the *galerie* of the Green Tree Tavern, Ste. Genevieve, Missouri.

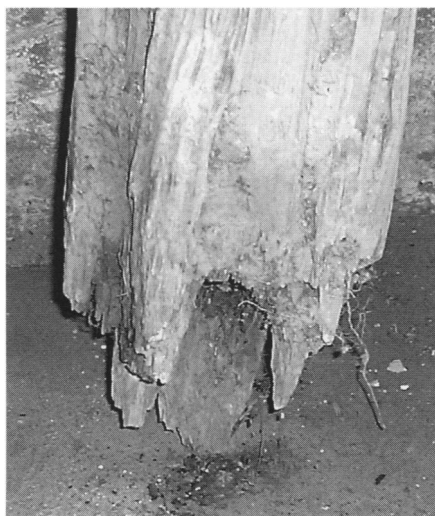
Fig. 5. Profile of a decayed eastern-red-cedar post.
